Possible failure mechanisms of landslides in loess deposits

Dissertation

Raushan Mamyrova

2012

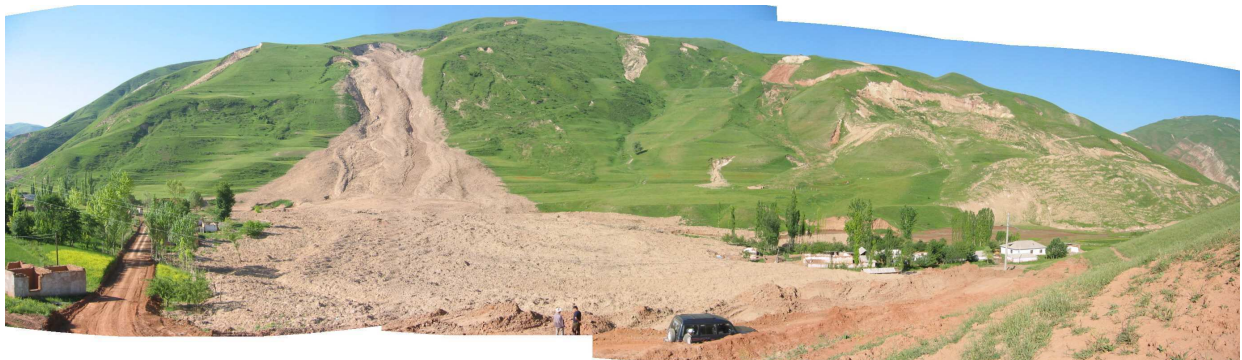
Fig. 1-1: The Kainama landslide in South Kyrgyzstan (Photograph by I.A. Torgoev, 2004)

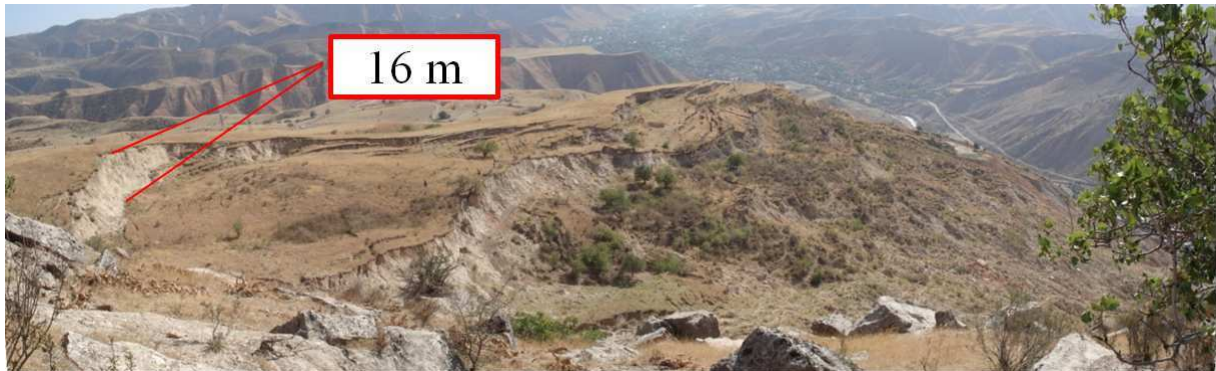
Fig. 2-10: Tektonik landslide presenting scarps with 16 m

The Tektonik landslide with a volume of 1.5 million m³ formed in 1992. This case can be specified as one of the most disastrous because it buried the waste tailing #17 (17 - the number of tailing) and partly destroyed the plant “Kyrgyzelektroisolit” (VANDENHOFE et al. 2003). Moreover, it has dammed the Mailuu-Suu River, though the damming of the river occurred in 1994, 2002 and 2005 (HAVENITH, 2006b). This complex landslide formed new scarps on the upper part of crest. During the field works that took place in September 2008, the scarp was observed to be 16 m as it is shown in Fig. 2-10.

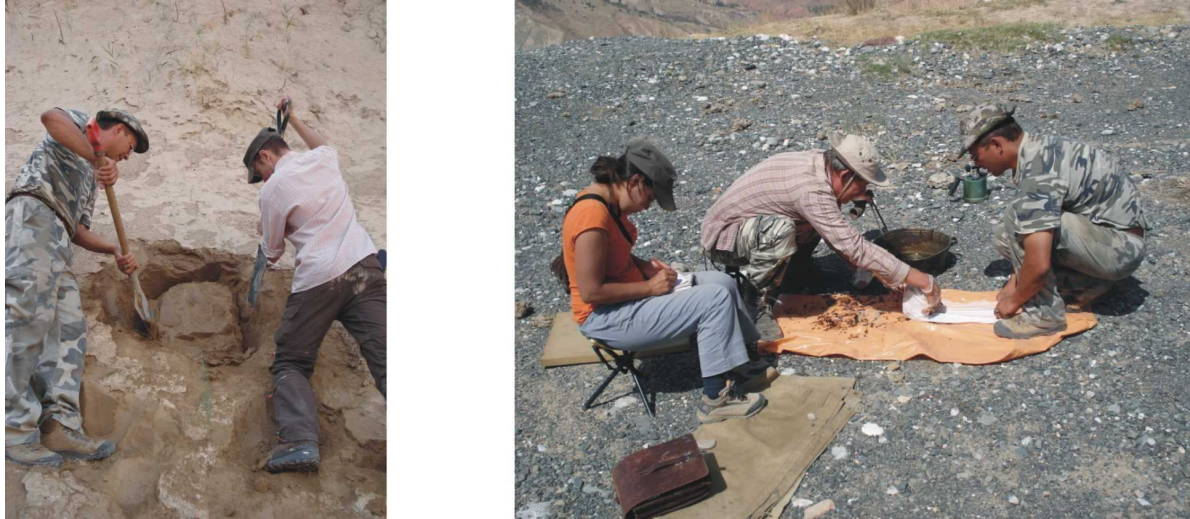
Fig. 7-3: Sampling of loess (left), and preservation of the sample to enable transport to laboratory (right)

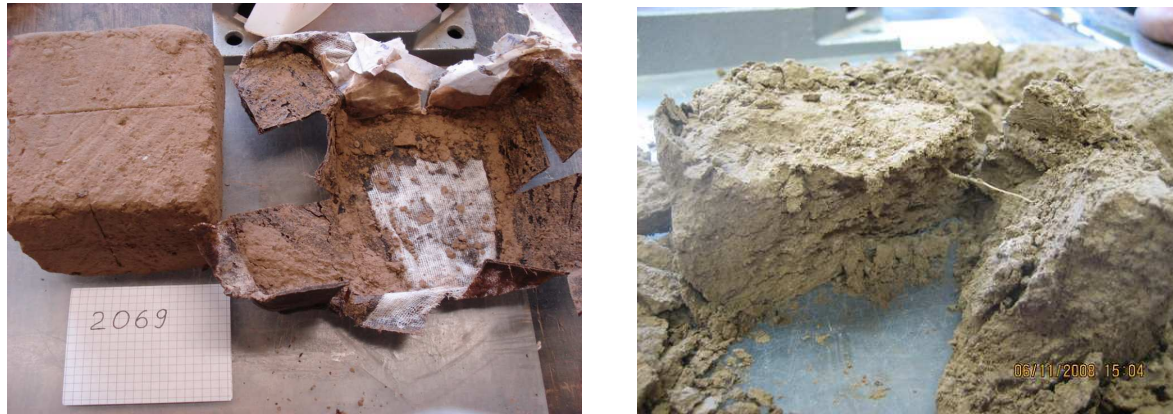
Fig. 7-6: Loess sample after removal of the paraffin wax (left photo) and collapsibility of loess observed during the preparation of sample to testing (right photo)

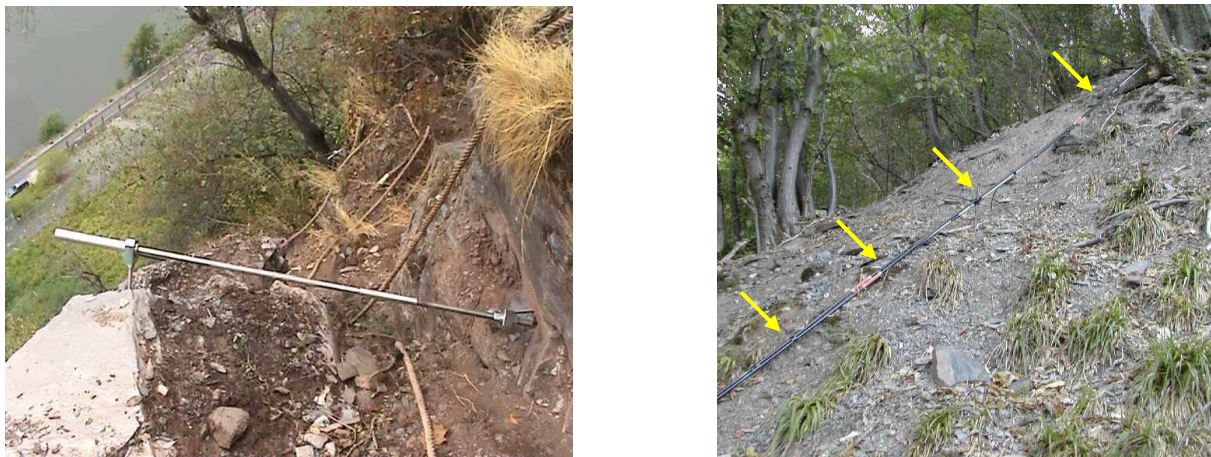
Fig. 9-5: A fissurometer and a surface-extensometer in action, Traben Trarbach (Germany) (KRAUTER et al. 2004)
